Maintenance of a Vertical Flow Pond & Wetland System Used to Treat AMD

October 24-26, 2023 *Altoona, Pennsylvania* **PRESENTER:**

2023 PENNSYLVANIA ABANDONED MINE RECLAMATION CONFERENCE

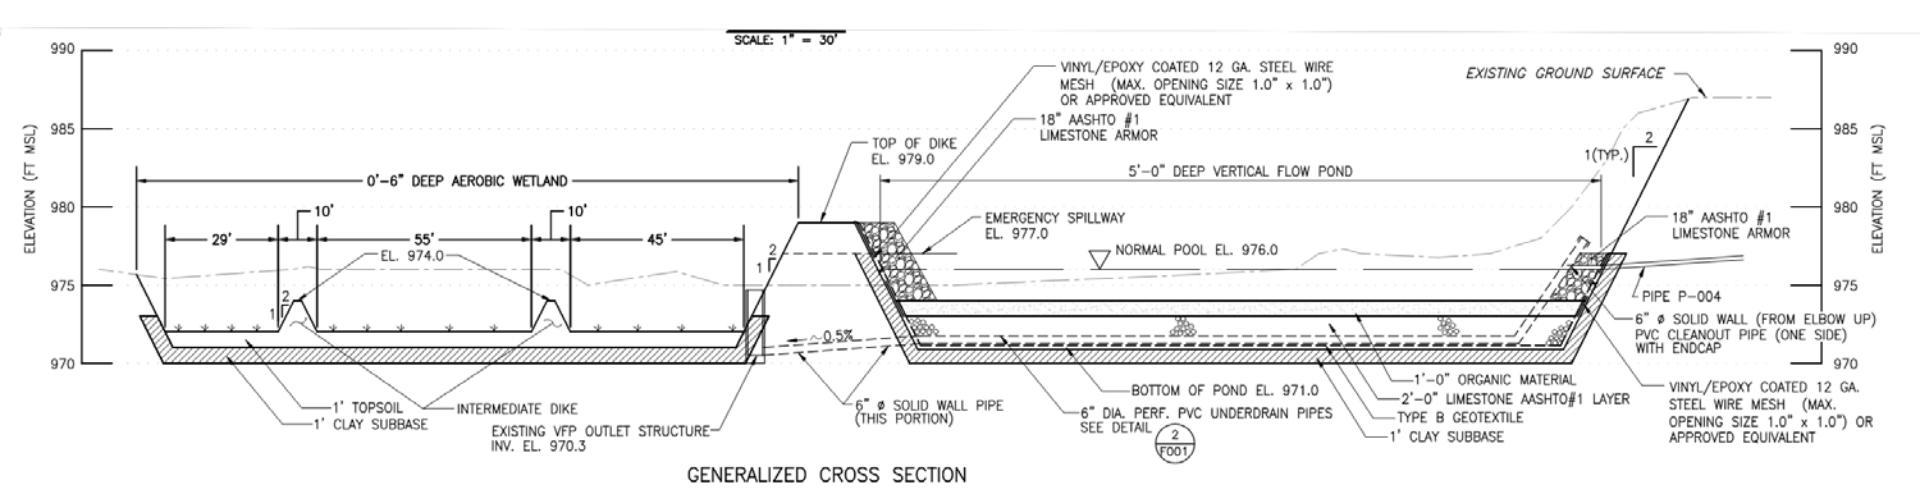
CROSS SECTION

- Vertical Flow Pond
- Aerobic Wetland

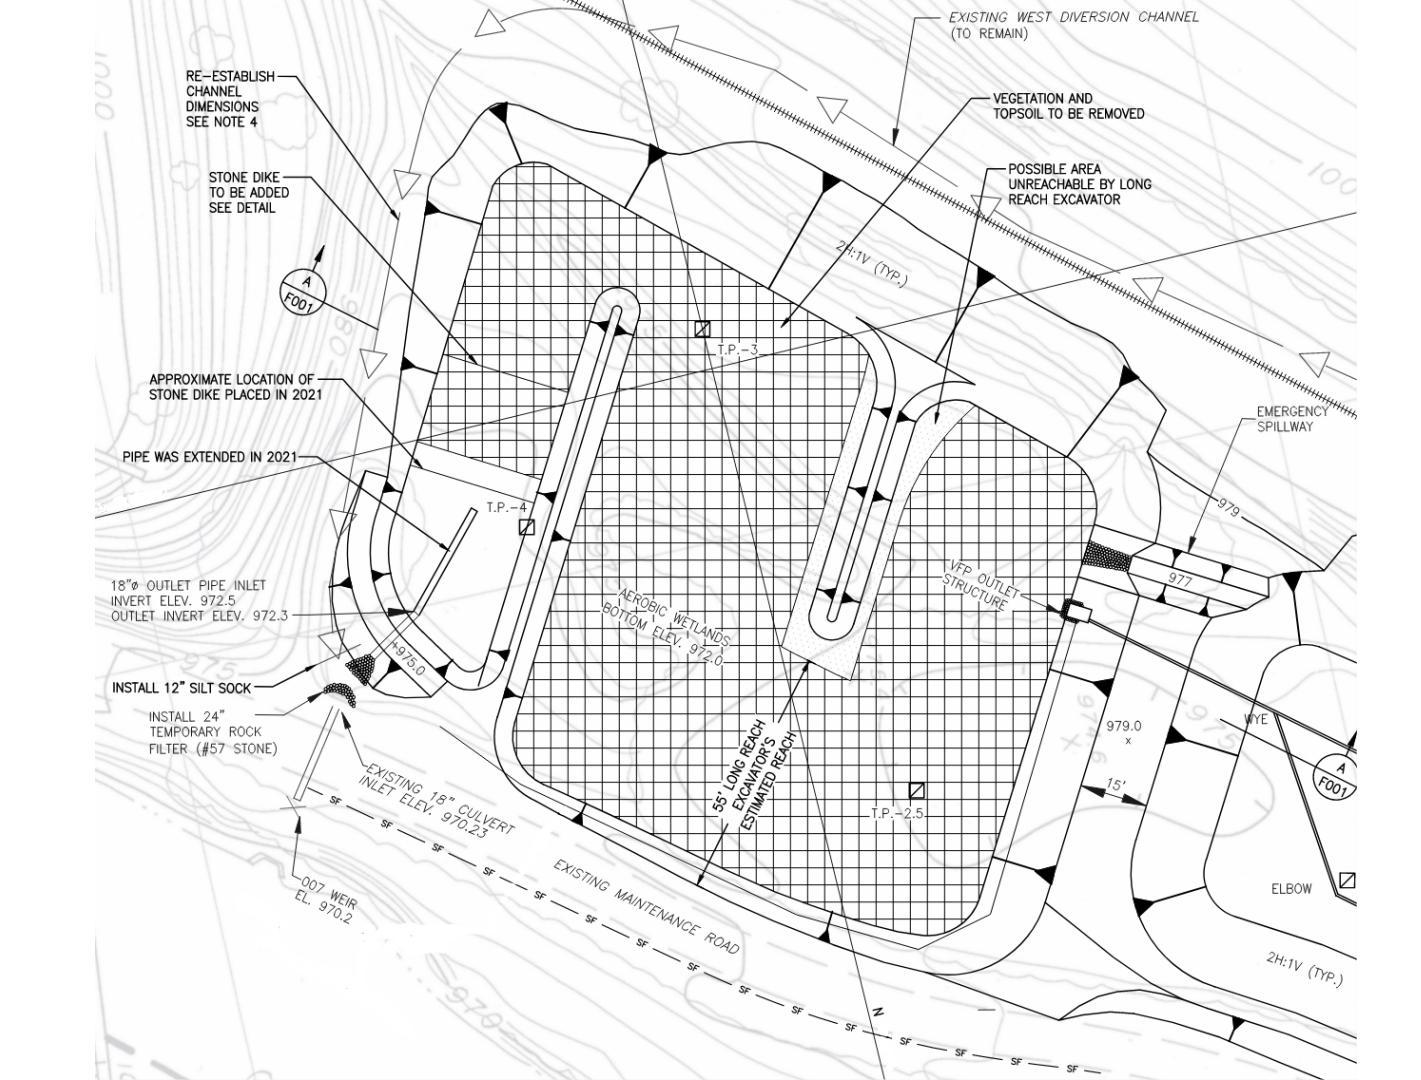
PLAN VIEW

WETLAND PRIOR TO MAINTENANCE

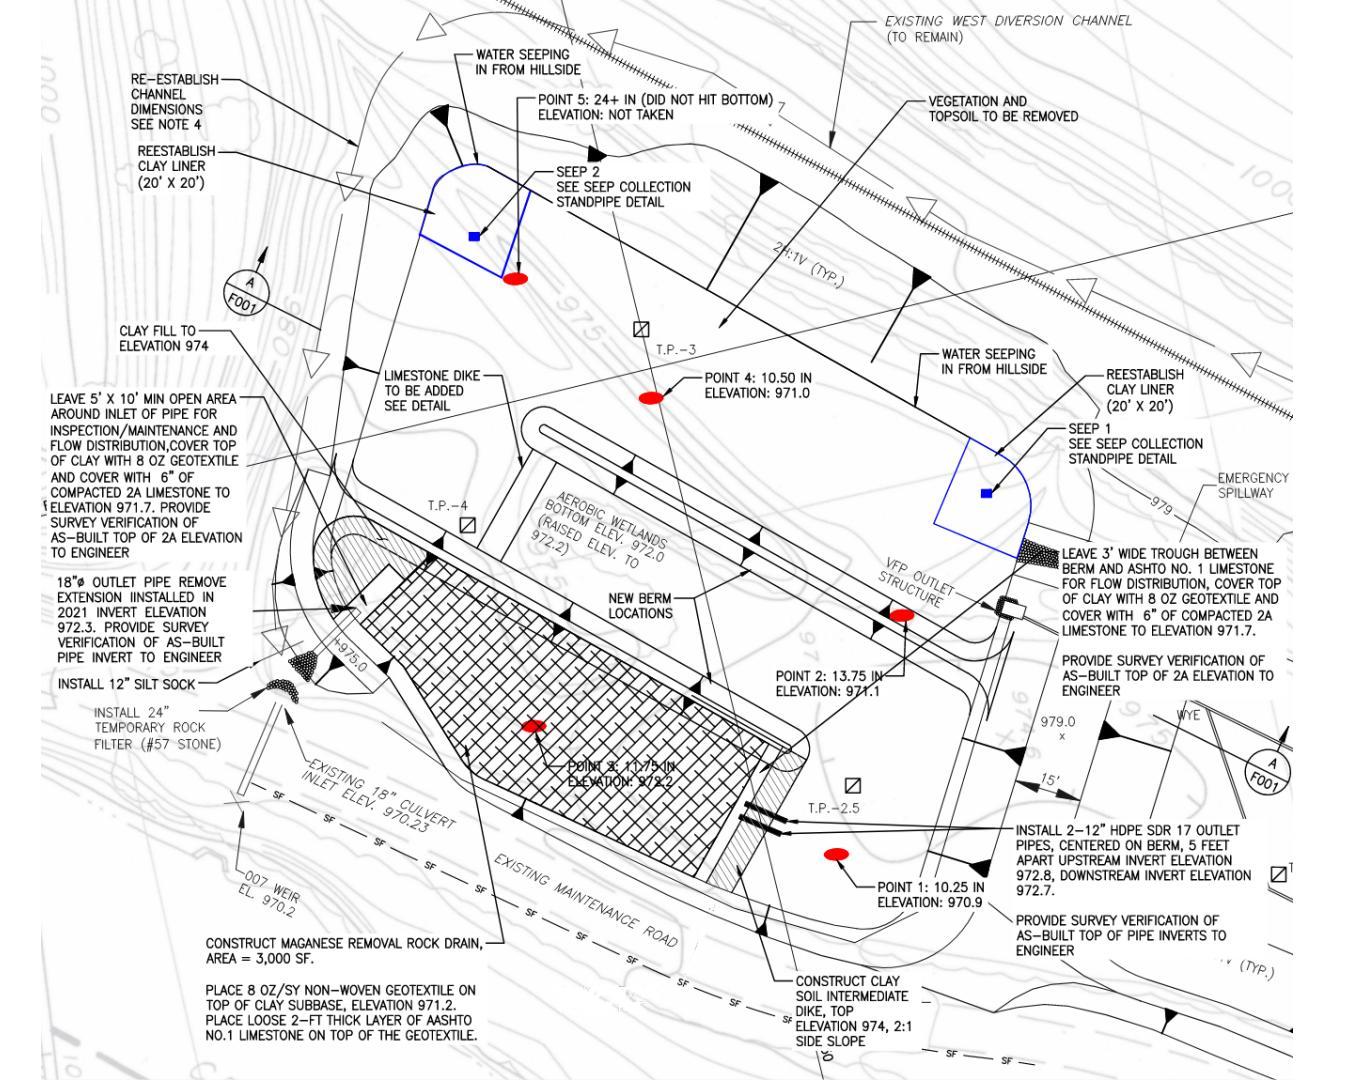
WETLAND MAINTENANCE: SEEP IDENTIFIED DURING CONSTRUCTION
