Maintenance of a Vertical Flow Pond & Wetland System Used to Treat AMD

October 24-26, 2023 *Altoona, Pennsylvania* **PRESENTER:**

2023 PENNSYLVANIA ABANDONED MINE RECLAMATION CONFERENCE

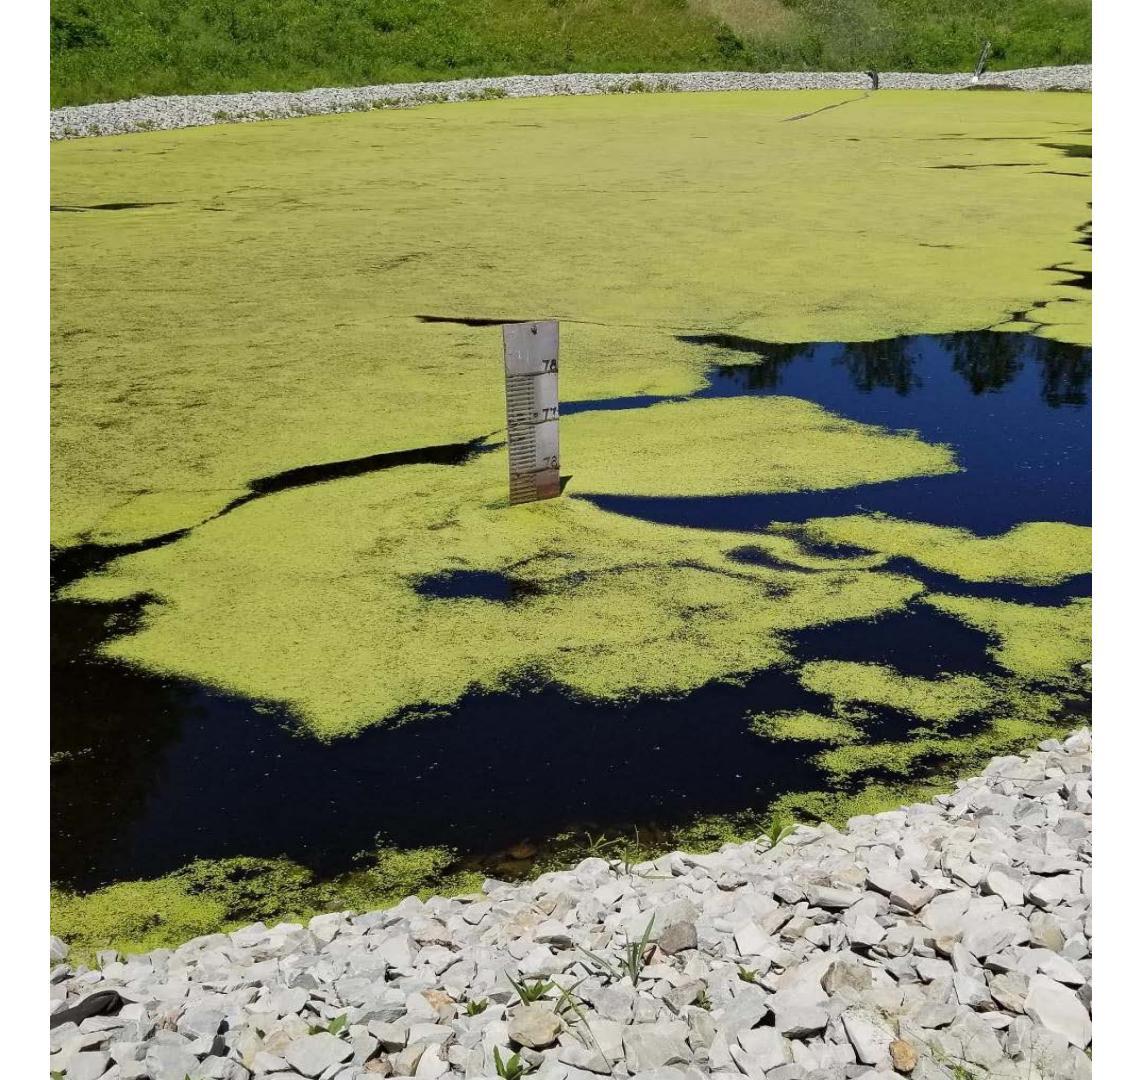
POST-CONSTRUCTION

- Regular Maintenance Expected
- > 20 Years of Operation
 - > Minimal Armoring of Limestone
 - Pipes Were Not Clogged
- Flow Conditions Change Over Time
 - > Seeps, Short Circuiting
- Excellent Water Quality Post-Construction

- Repaired 1' Clay of Base
- Replaced Limestone
- Replaced Compost
- Cleaned Underdrain Pipes
- Installed 12-guage Wire Mesh
- 2020 VFP Maintenance
 - Same as 2010
 - Used GCL
- 2022 Wetland Maintenance
 - Replaced 1' Topsoil
 - Regraded and Changed Berm Geometry
 - Installed Manganese Removal Rock Drain
 - Replaced Vegetation

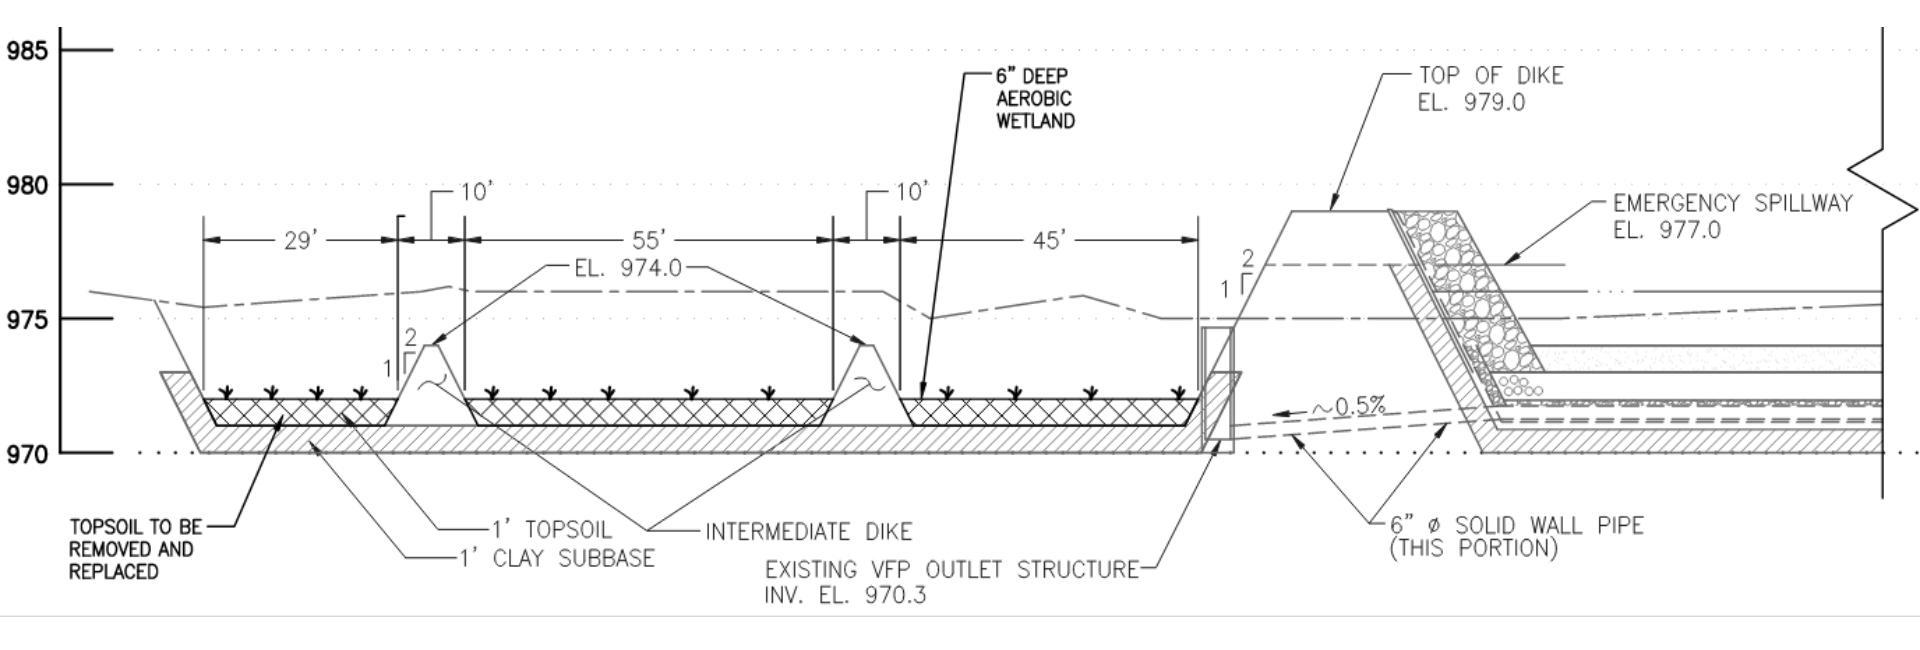
CROSS SECTION

- VFP Flow and Elevation Dropping
- Suspected Dike Leak into Wetland
- Wetland Treatment Chemistry Declining
- Seeps Identified in Wetland
- Short Circuiting
